DEPARTMENT OF TRANSPORTATION

Contract #: 04-0120F4Cty: SF/ALA Rte: 80 PM: 13.2/13.9File #: 69.28**WELDING INSPECTION REPORT****Resident Engineer:** Pursell, Gary**Address:** 333 Burma Road**City:** Oakland, CA 94607**Report No:** WIR-011691**Date Inspected:** 21-Jan-2010**Project Name:** SAS Superstructure**OSM Arrival Time:** 645**Prime Contractor:** American Bridge/Fluor Enterprises, a JV**OSM Departure Time:** 1845**Contractor:** Zhenhua Port Machinery Company, Ltd (ZPMC), Changxing Island **Location:** Shanghai, China**CWI Name:** Li Yang**CWI Present:** Yes No**Inspected CWI report:** Yes No N/A**Rod Oven in Use:** Yes No N/A**Electrode to specification:** Yes No N/A**Weld Procedures Followed:** Yes No N/A**Qualified Welders:** Yes No N/A**Verified Joint Fit-up:** Yes No N/A**Approved Drawings:** Yes No N/A**Approved WPS:** Yes No N/A**Delayed / Cancelled:** Yes No N/A**Bridge No:** 34-0006**Component:** Orthotropic Box Girder (OBG)**Summary of Items Observed:**

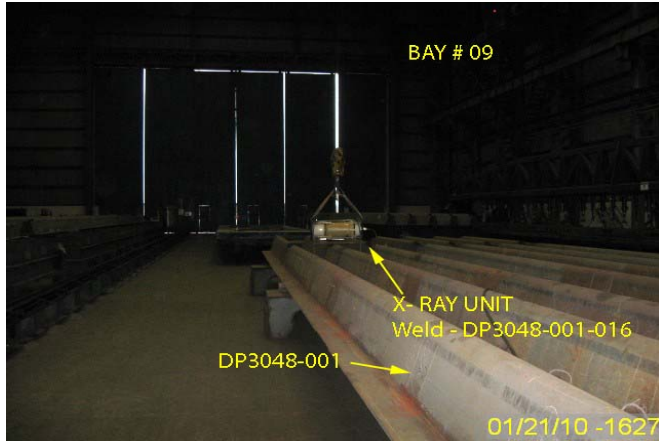
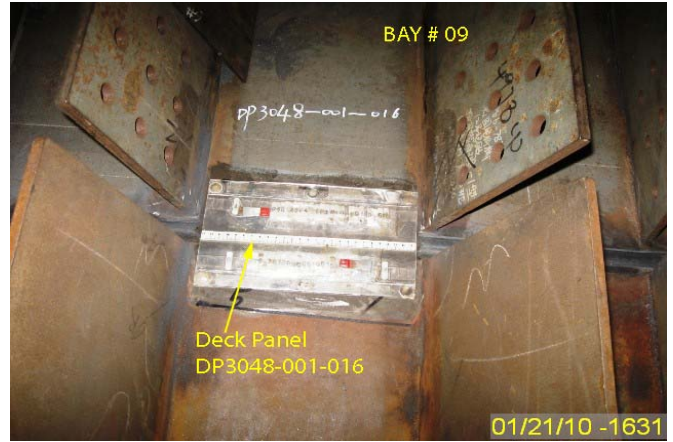
This QA observed that ZPMC Radiography (RT) personnel identified as Mr. Yunshu performing RT on Deck Panel weld joint is identified as DP3048-001-016. RT technique appeared to be in general compliance with the contract documents during the time QA was present. See attached picture.
